INVESTIGATION OF INTERNAL CORROSION AND EVALUATION OF  
NON-SKID COATINGS ON MARK 7 JET BLAST DEFLECTORS

Naval Air Engineering Center  
Lakehurst, New Jersey

10 December 1975

**NAEC-ENG-7875**

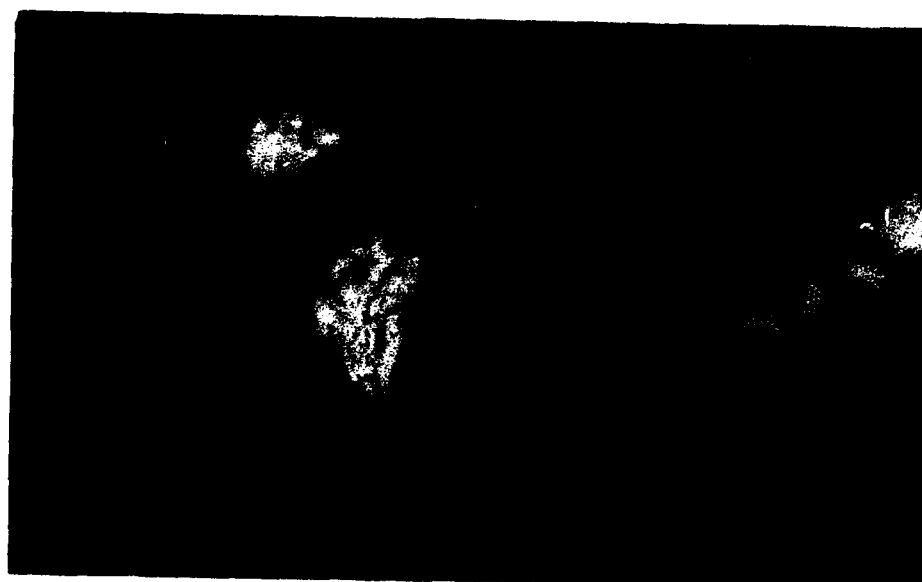
Other areas of the Mark 6 JBD module showing severe corrosion were the inlet and outlet header pipes. The ends of the pipe had deteriorated to the point where the metal surface resembled a sponge (Figure 10). It appears that this attack is primarily due to crevice corrosion. Aluminum alloys are notoriously susceptible to crevice corrosion. A crevice is formed at the header pipe when non-metallic connecting hoses are clamped over the pipes. Use of a high temperature sealant at the connection joint might remedy the problem. There was no evidence of significant erosion attack on the internal surface of the header pipe at the 90° elbow. This would indicate the characteristic flow rates through the JBD panels are tolerable.

FIGURE 10 - Corrosion Attack on Inlet Pipe on  
Mark 6 JBD Panel Removed From  
USS Kitty Hawk
